Ravnsborg/Boever Pedestrian Fatality

RAVNSBORG / BOEVER PEDESTRIAN FATALITY CRASH

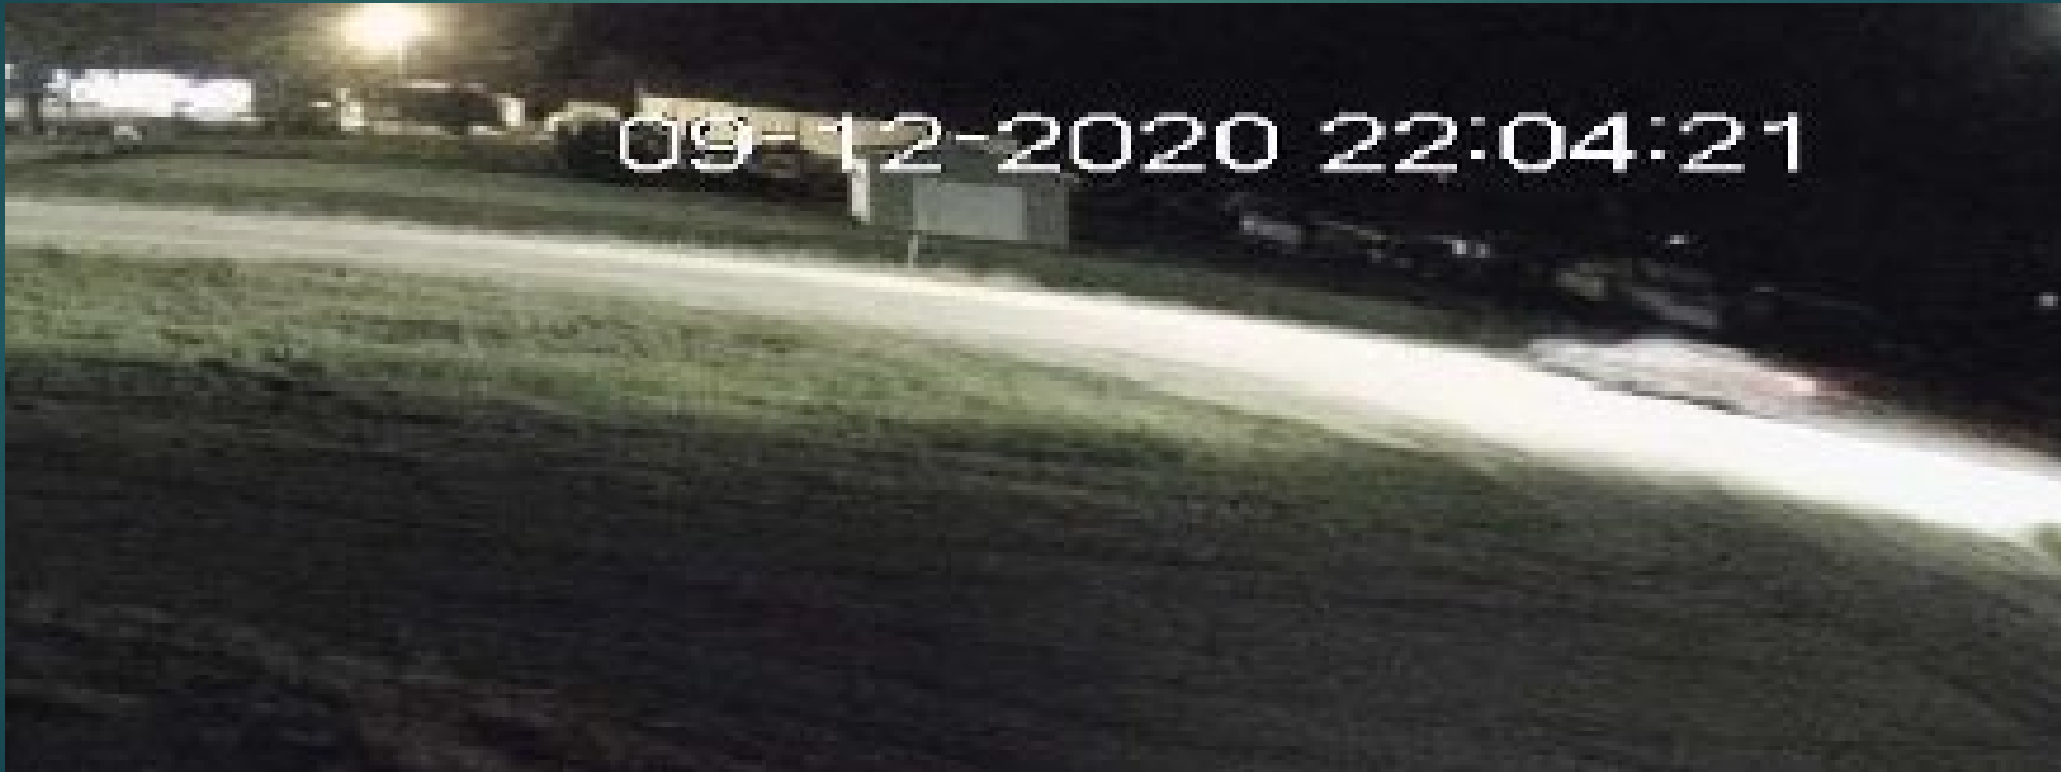
Miller, SD [10:04pm]

► FarmTech Video

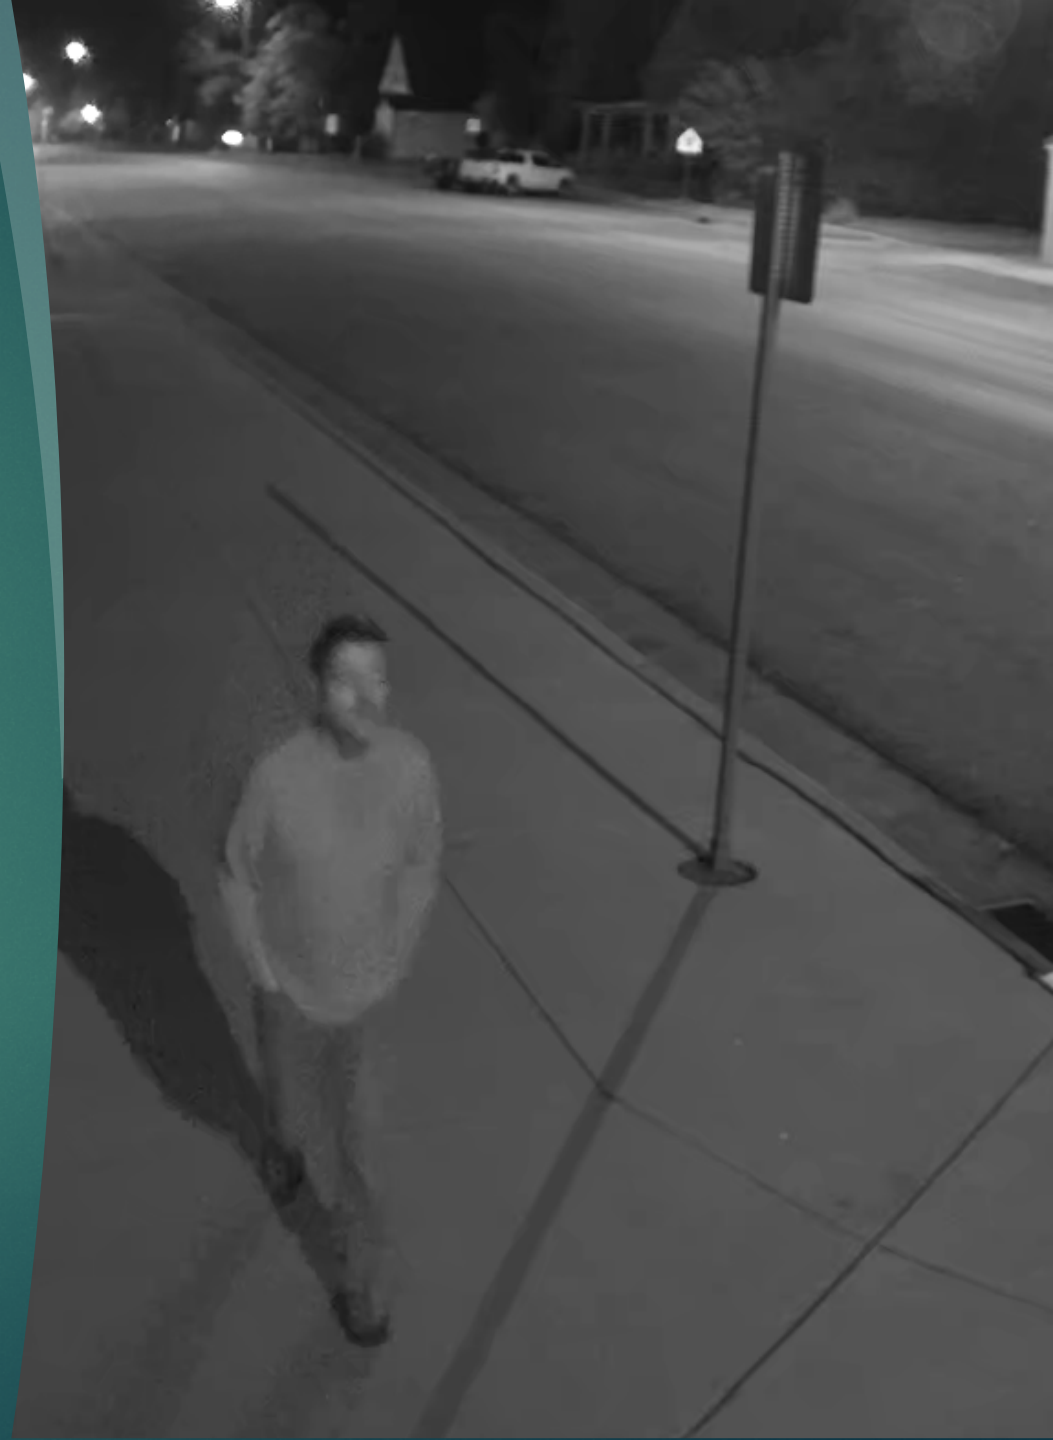
Boever Evidence

- ▶ Flashlight – Found along shoulder (still on)
 - ▶ Witness saw MR Boever with a light
 - ▶ Witnesses stated MR Boever was walking on shoulder near ditch
 - ▶ Witness talked to MR Boever and believed he may be intoxicated
- ▶ Video of MR Boever
 - ▶ Walking on SD47 (Inside Highmore City Limits) at 9:31pm
 - ▶ Mashek Grocery
 - ▶ No issues walking
 - ▶ No impairment observed
- ▶ Toxicology shows higher than normal levels of Lorazepam prescription

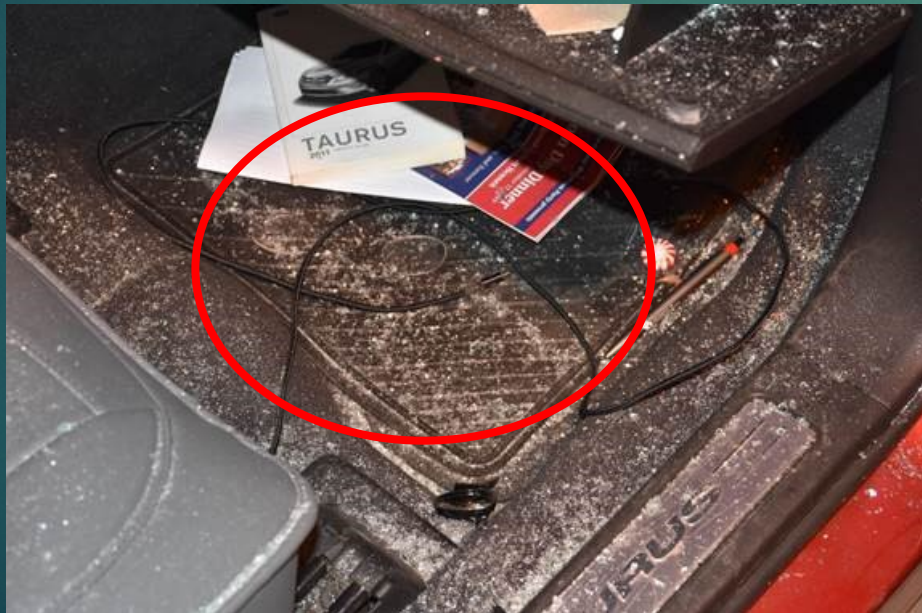
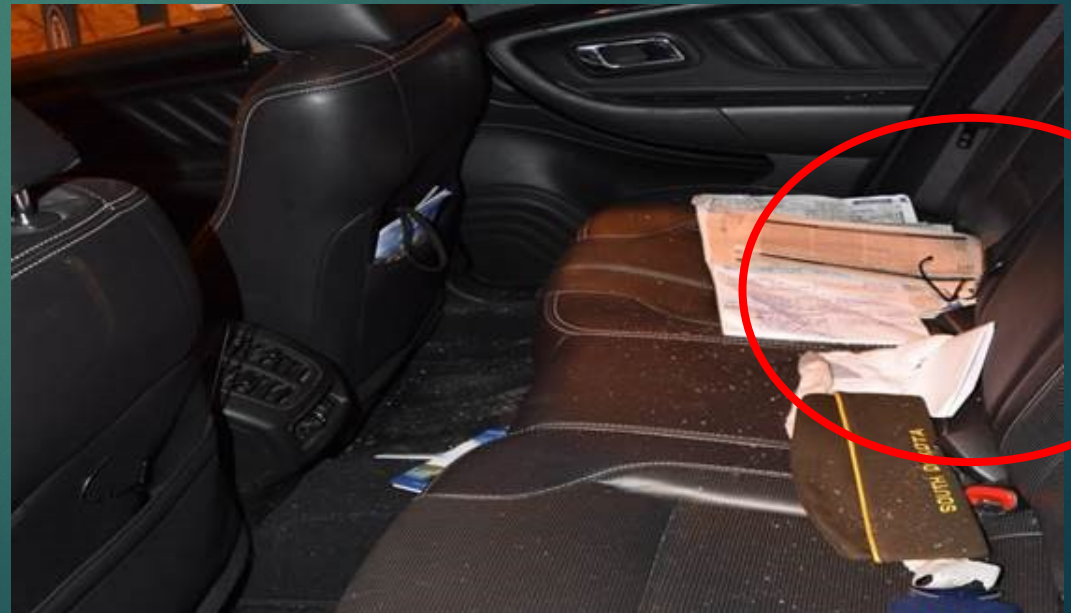
Boever Evidence

- ▶ Direction of Travel: Eastbound
 - ▶ Autopsy
- ▶ MR Boever's broken glasses found inside AG Ravensborg's vehicle

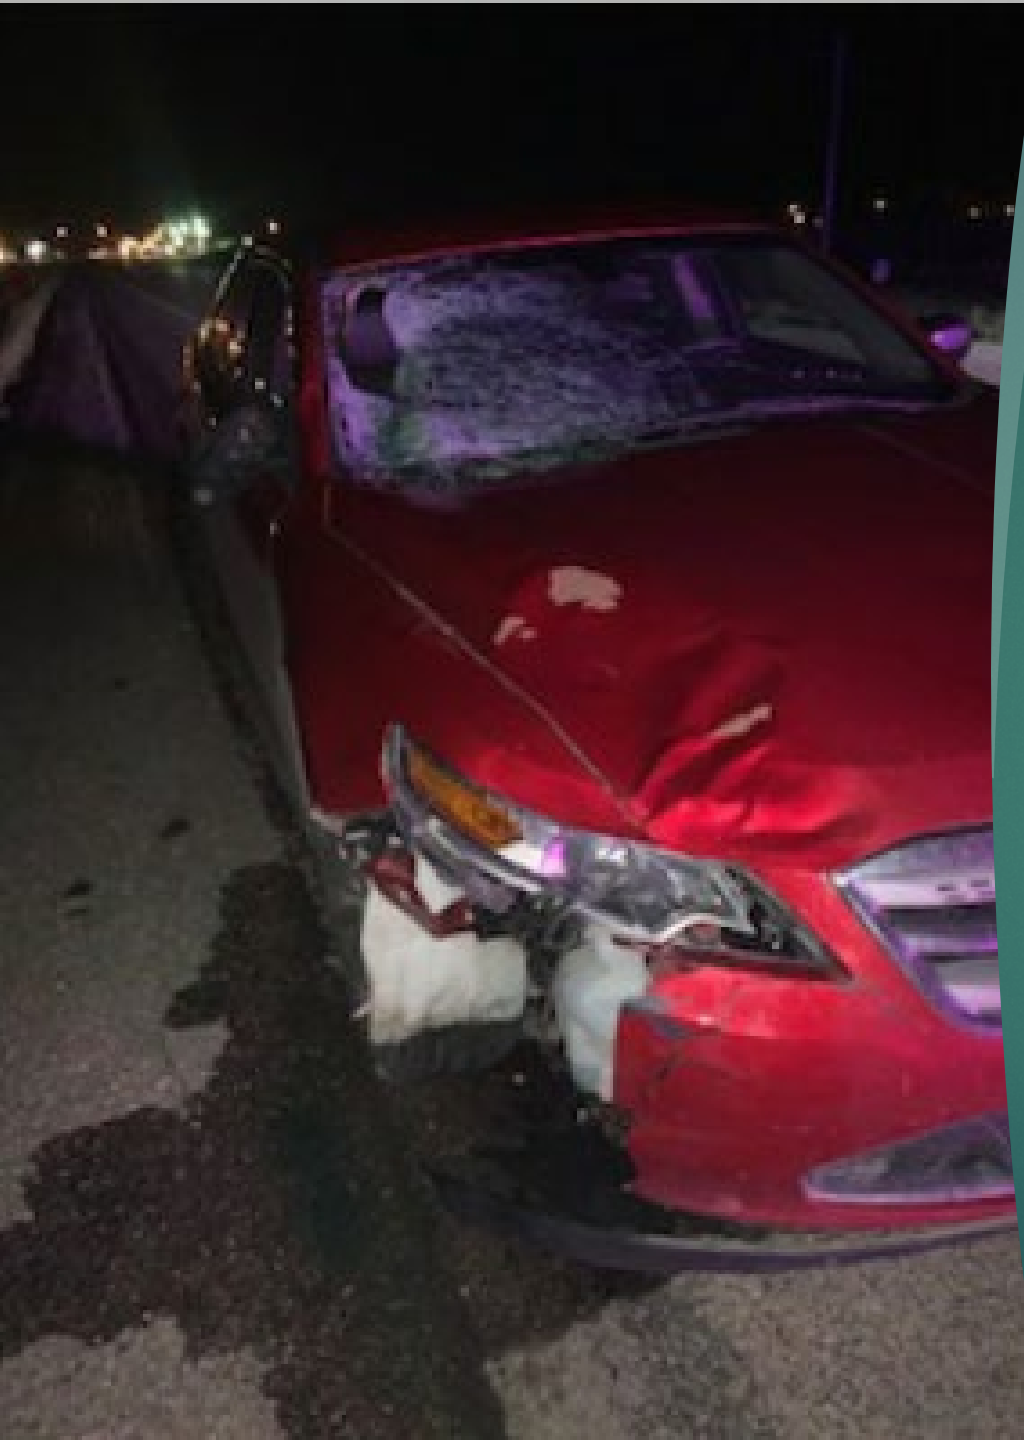
Crash Scene

- ▶ AG Ravensborg accelerates to *68-mph*
 - ▶ Based on phone location information
 - ▶ Speedometer would indicate approximately *72-mph*
- ▶ Traveling completely on shoulder of the roadway
 - ▶ *10-ft 8-in* wide
- ▶ Strikes MR Boever approximately *1-ft* from edge of grass

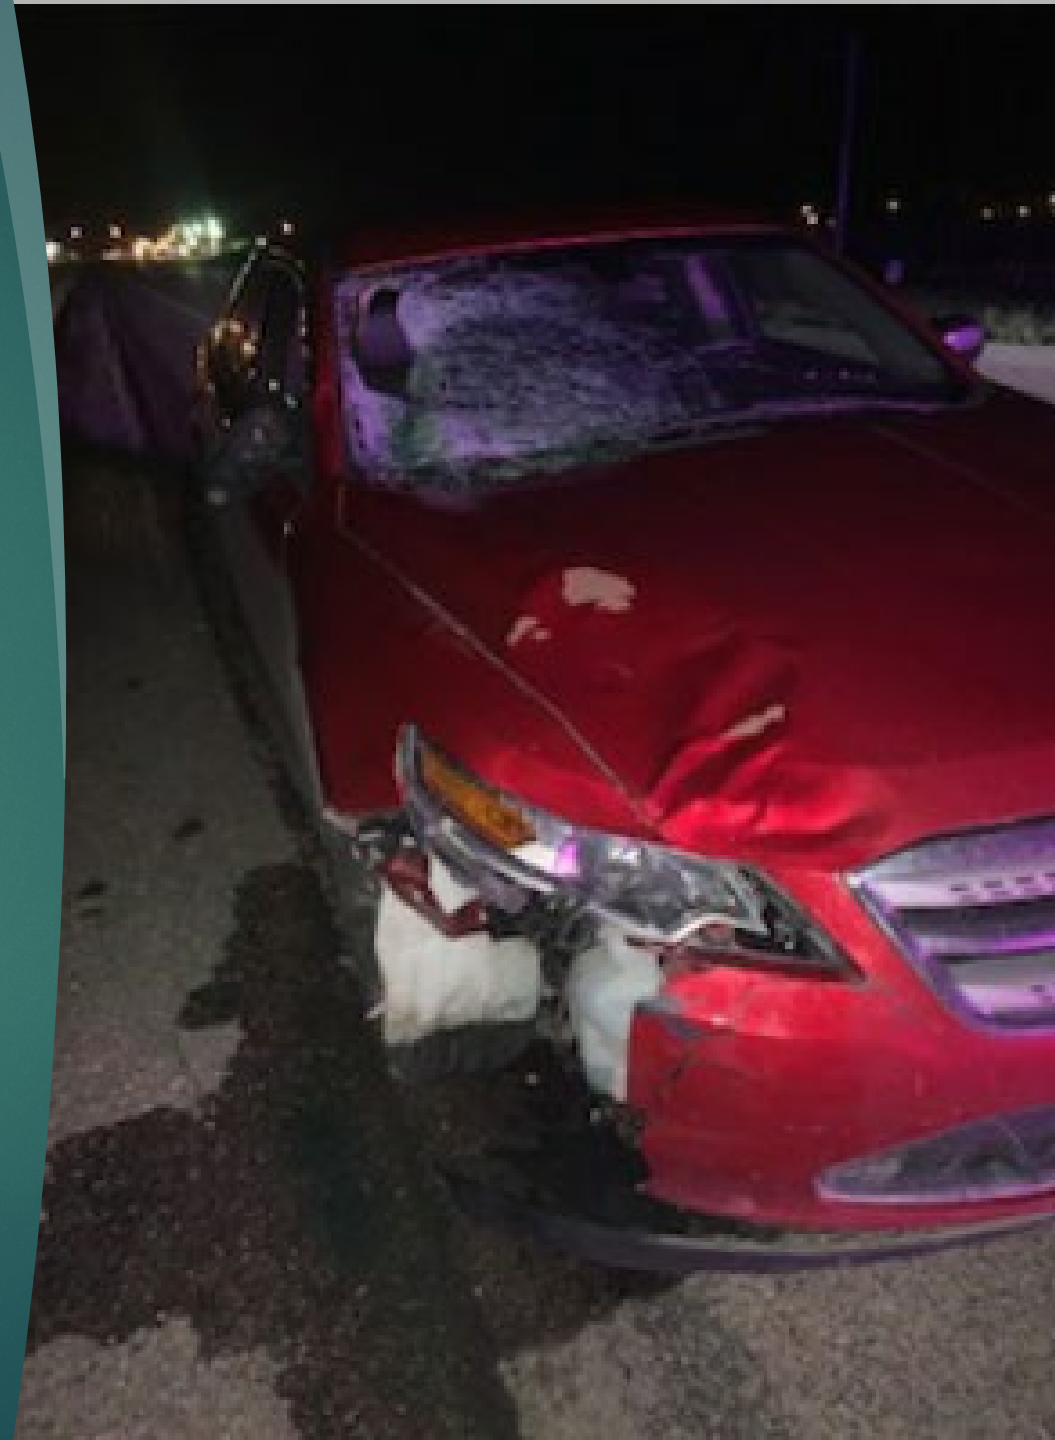
Post-Crash Events

- ▶ AG Ravensborg takes a photo of his vehicle [10:33:22pm]
- ▶ AG Ravensborg states that Sheriff Volek arrives at this approximate time

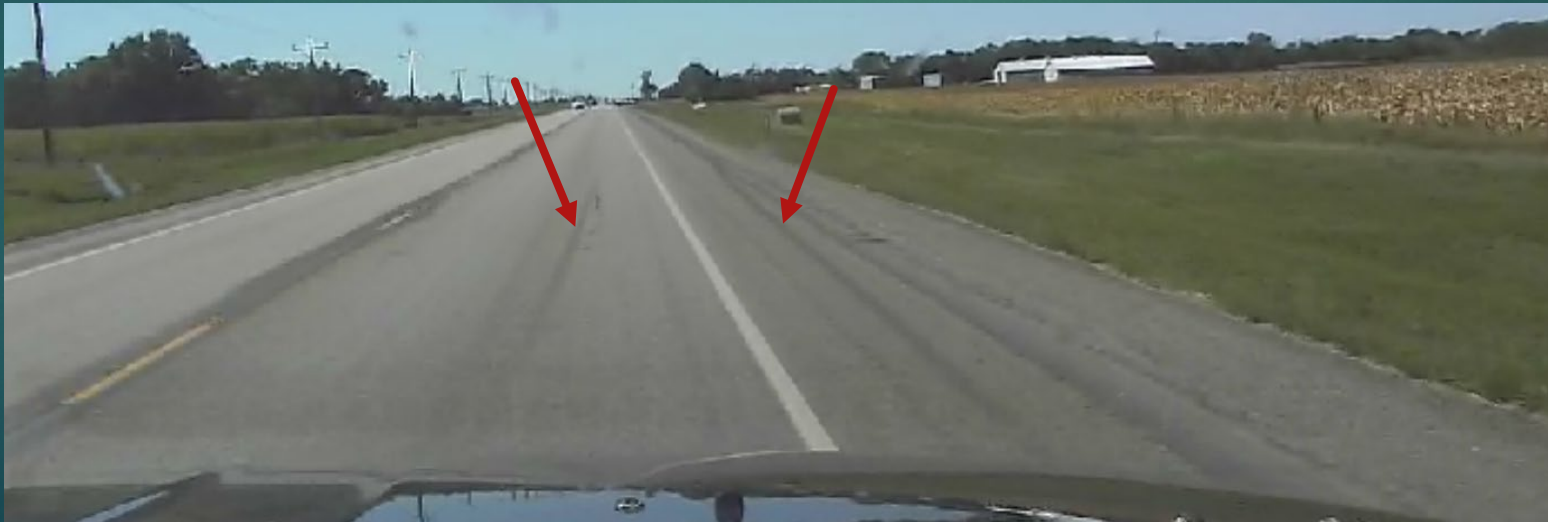
Post-Crash Events

- ▶ Skid marks observed near crash site
- ▶ Skid marks determined to be from another vehicle
 - ▶ Track width of AG Ravensborg vehicle is narrower
 - ▶ AG Ravensborg vehicle has ABS
 - ▶ LT Stahl video prior to crash date [09/04/2020]

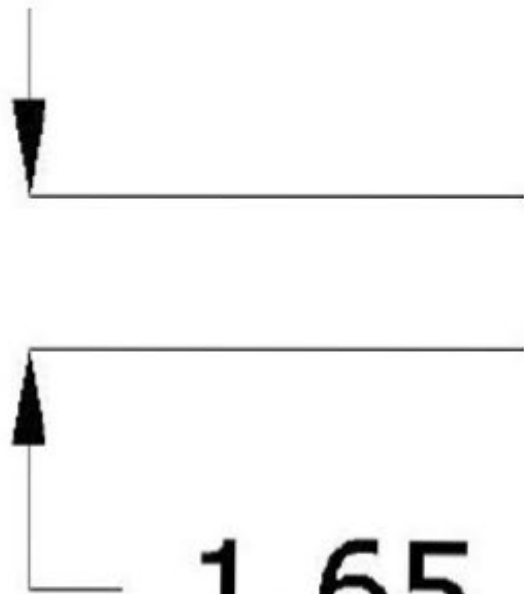
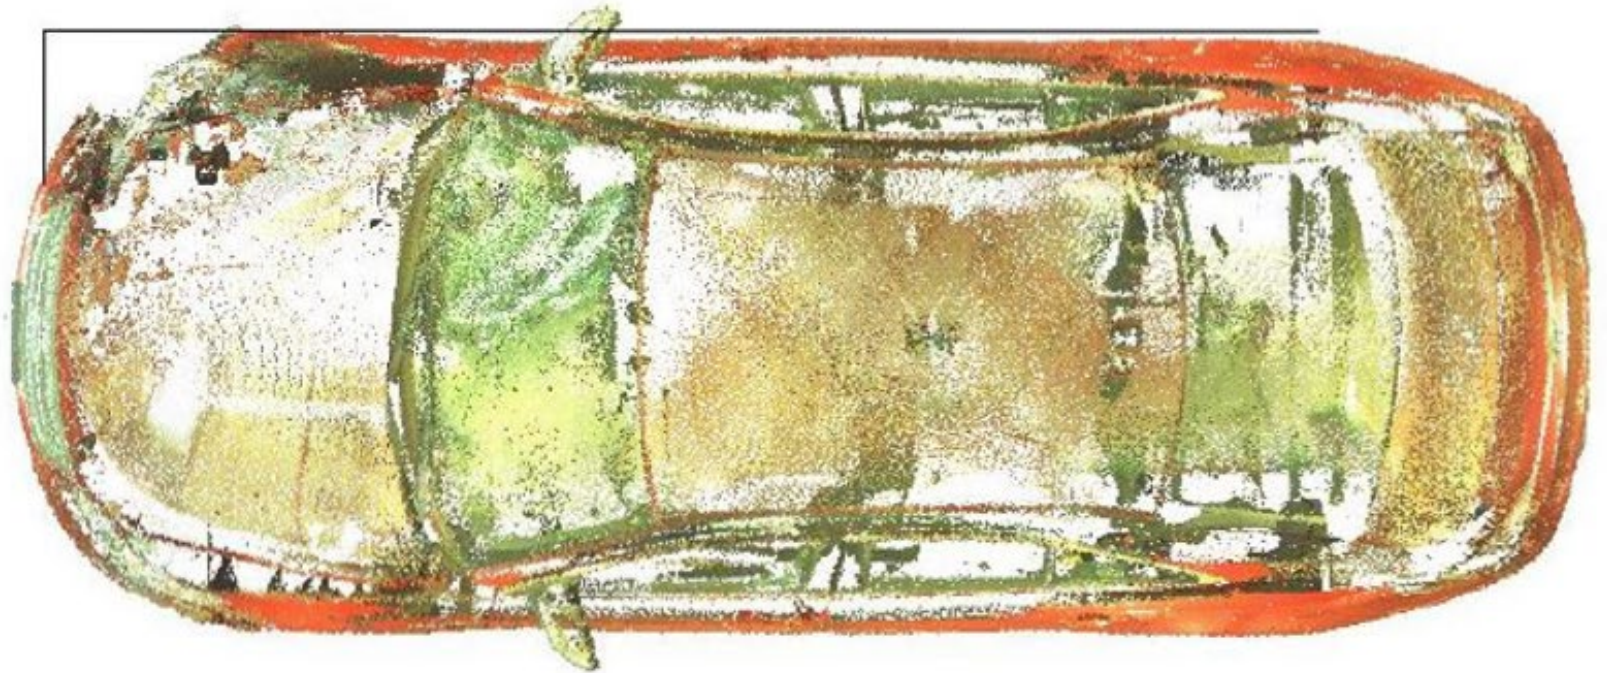
AG Ravensborg Vehicle

- ▶ Regularly serviced
- ▶ Involved in prior crashes
- ▶ AG Ravensborg admits to hitting deer in the past
- ▶ Passenger side windshield has hole in it
 - ▶ Relates to glass spread on shoulder
 - ▶ Glasses inside vehicle
- ▶ Damage limited to 1.65-*ft* of passenger side

1.65

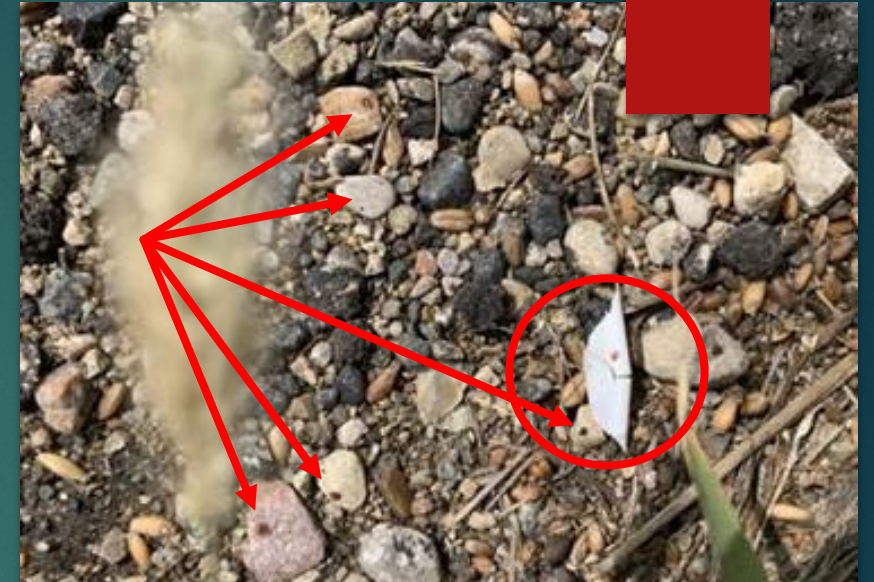
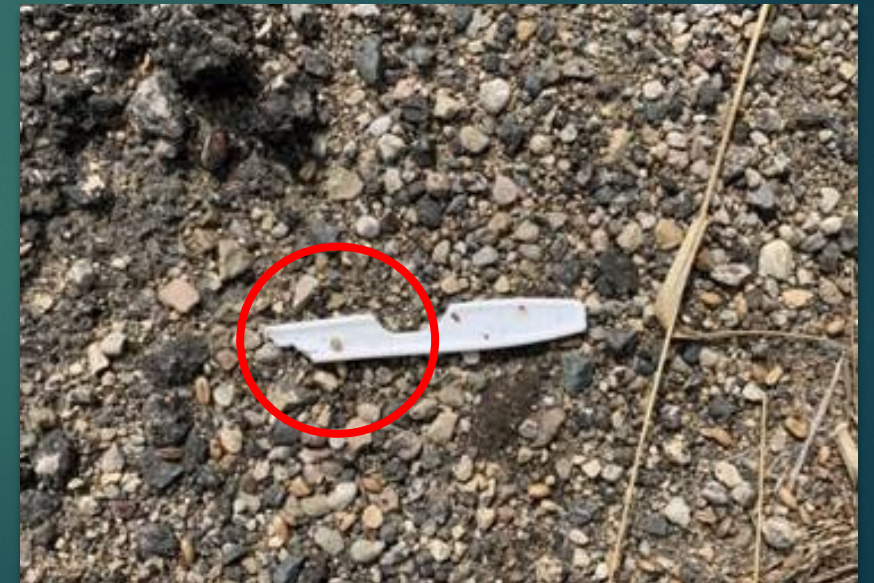
Evidence Mapped (Blood)

- ▶ High Velocity Spatter
 - ▶ Identified by North Dakota Bureau of Criminal Investigation Agents
- ▶ Samples taken from broken fork
 - ▶ Identified as human blood
- ▶ No blood was discovered in the westbound driving lane

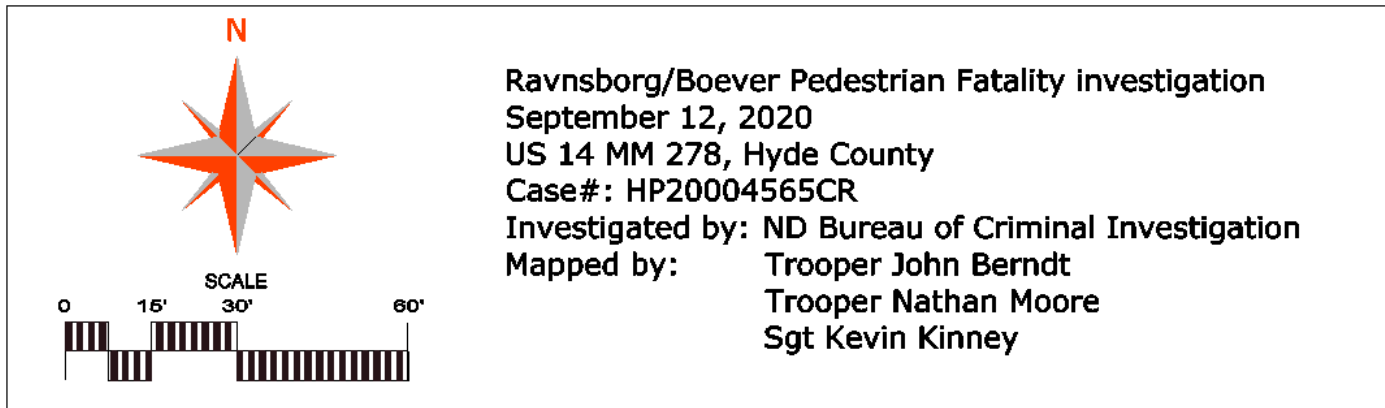
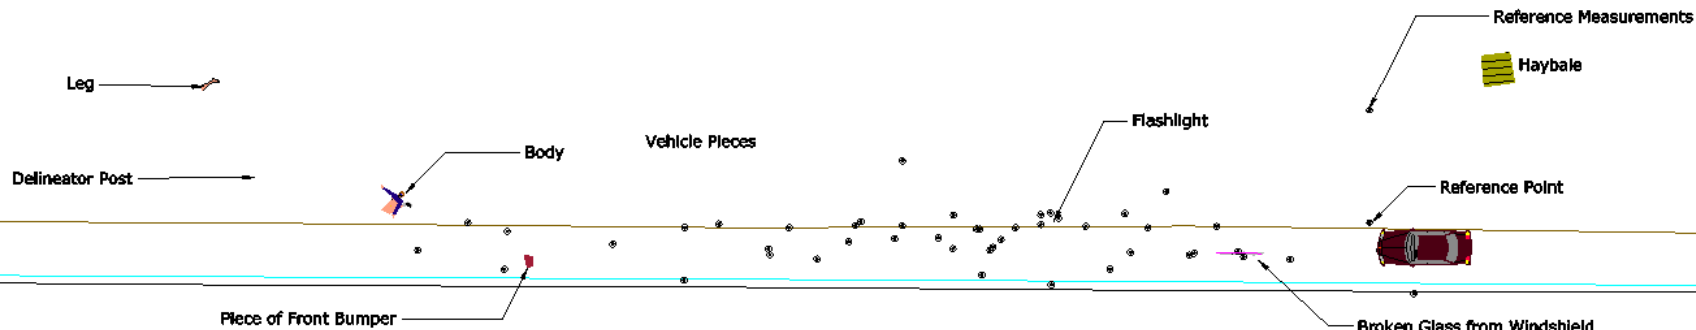
Evidence Mapped (Vehicle Parts)

- ▶ Various
 - ▶ Bolts
 - ▶ Washer Pump Motor
 - ▶ Broken Headlight Pieces
 - ▶ Broken Inner Wheel Well Pieces
 - ▶ Glass

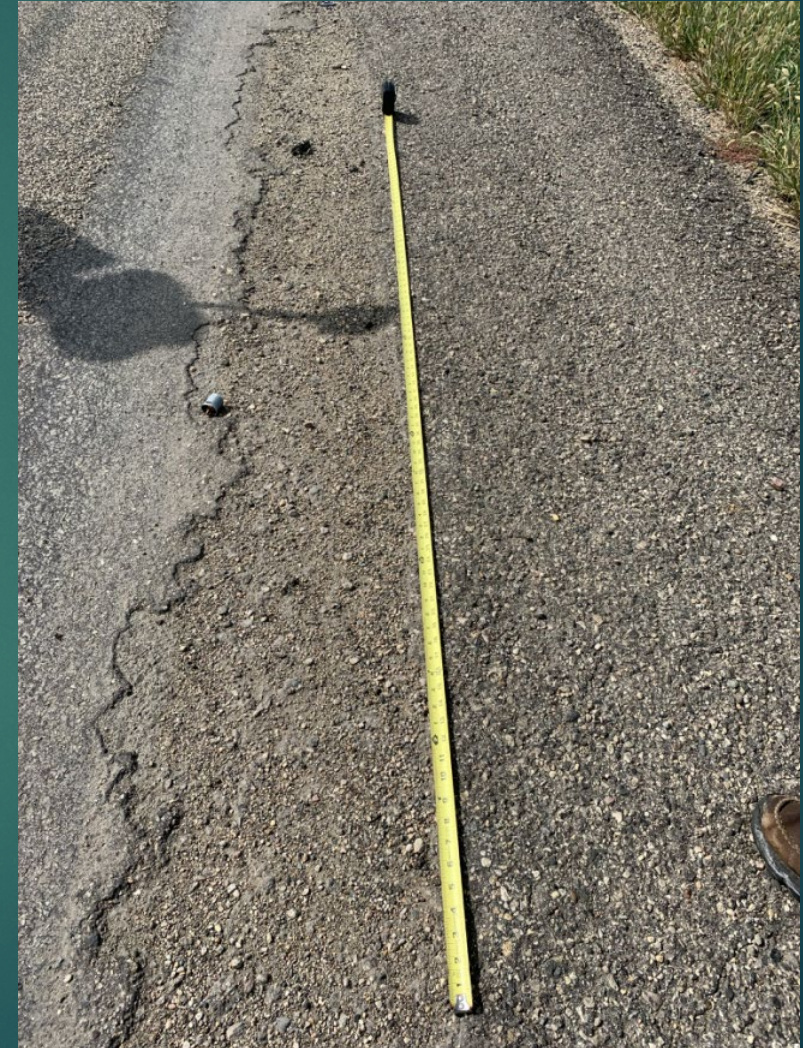
Evidence Mapped (Vehicle Parts)

- ▶ Glass
 - ▶ Formed approximately 8-*ft* long stretch
 - ▶ Non-reflective glass – from windshield

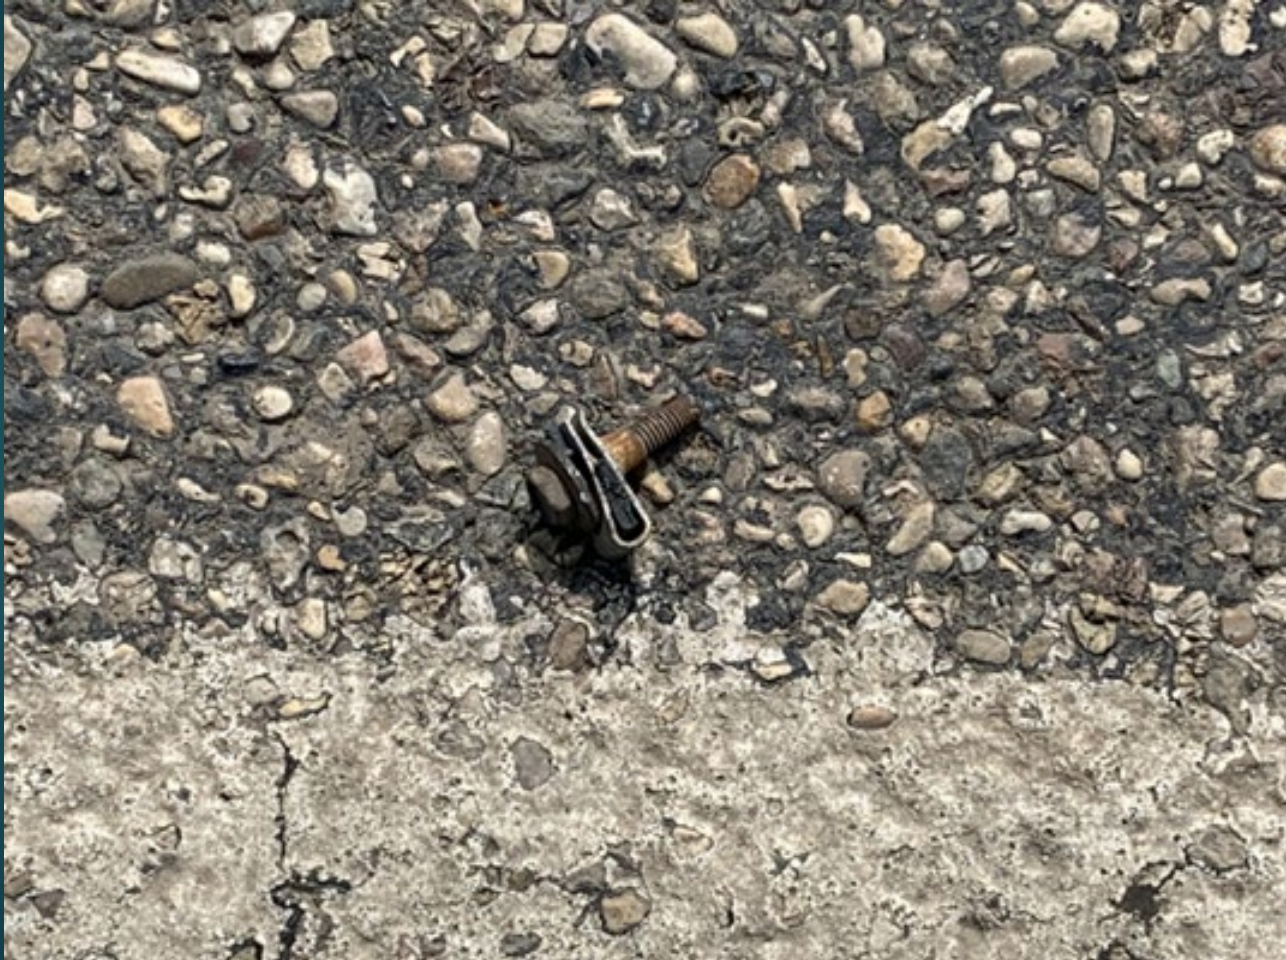
Evidence Mapped (Vehicle Parts)

- ▶ Bolt
 - ▶ Only part found in westbound driving lane
 - ▶ Approximately 2-in from fog line
